JRC 2014-3761

REHABILITATION, ASSESSMENT AND MANAGEMENT PRACTICES TO ENSURE LONG-LIFE, HIGH PERFORMANCE HIGHWAY-RAILWAY AT-GRADE CROSSINGS

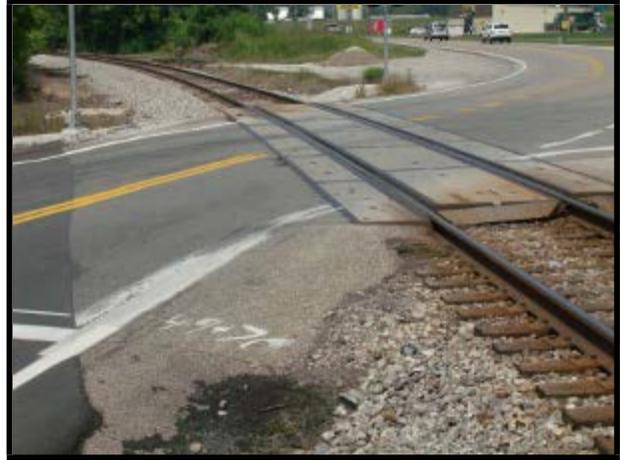
Figure 2a. CSX Crossing on WV Route 2 at Ashton, WV, Perfect Condition after 11 years.

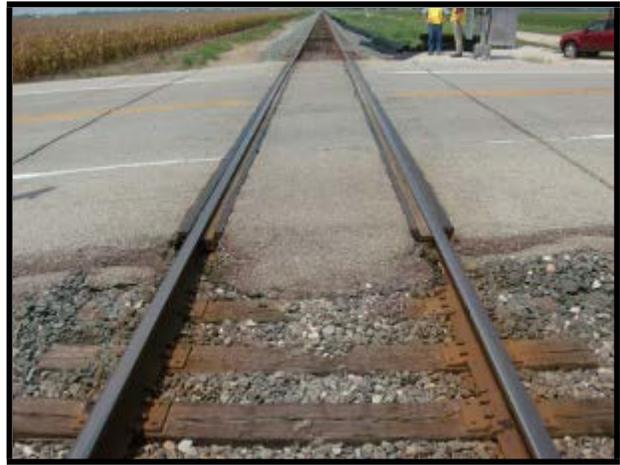
Figure 2b. CSX Crossing on US 60 West of Owensboro, KY, Perfect Condition after 10 years but Slated for Replacement, Note Saw Cuts.

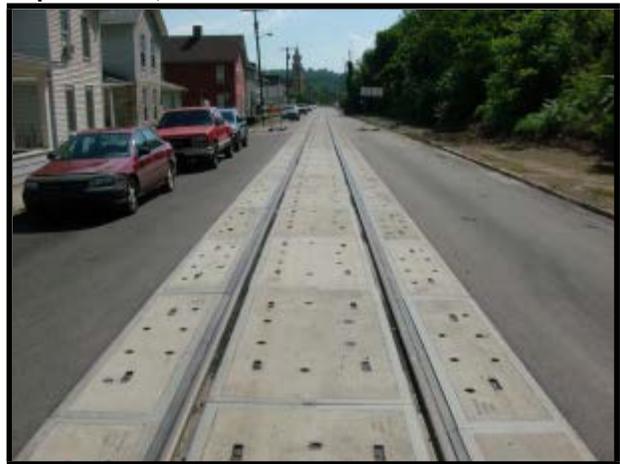
Figure 2c. NS Crossing in West Brownsville, PA, the 3226-ft (983-m) long Crossing is being Replaced in Segments over four years.

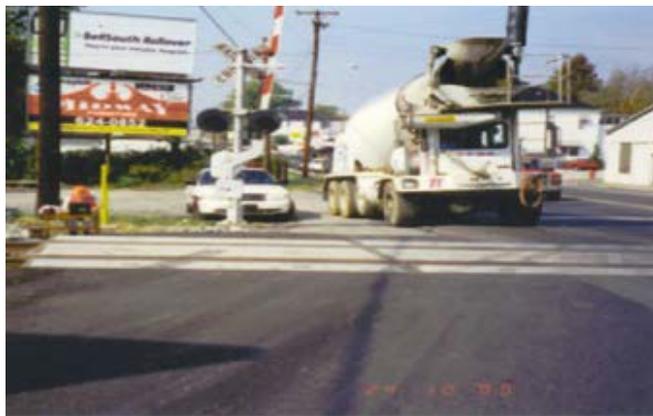
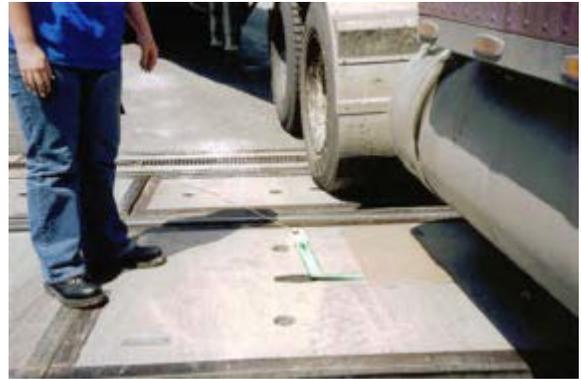
Figure 5. Imprint of Tractor Rear Tire of Loaded Coal Truck on Concrete Crossing.

Figure 5 shows the testing procedure and data for a typical 22-wheel, 150,000-lb (68 metric ton) gross weight loaded coal truck. The green areas indicate higher pressure intensities than the blue areas. The white areas are indicative of the tread which does not contact the pavement. Note that the calculated static contact pressure was 135 psi (930 kPa). The measured tire inflation pressure was 138 psi (950 kPa), very close to the Tekscan measurement calculated pressure. This is typical of maximum contact pressures experienced by crossing surfaces.

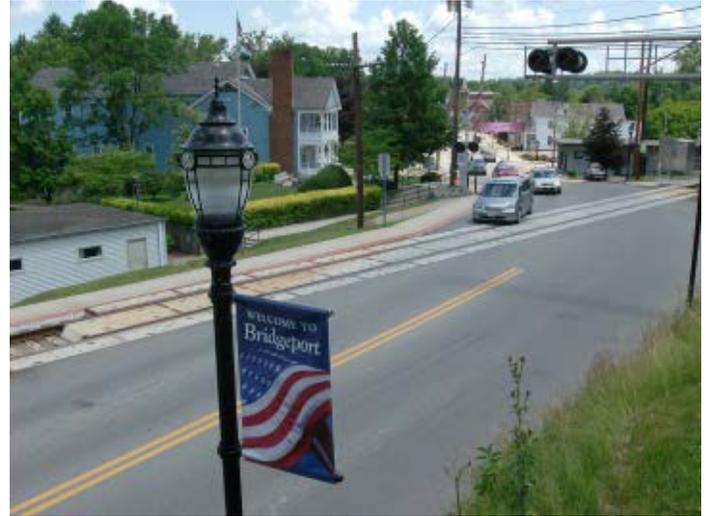
Figure 8. Recently Completed 144-ft (44-m) long Crossing on US 50 on CSX Line in Bridgeport, WV.

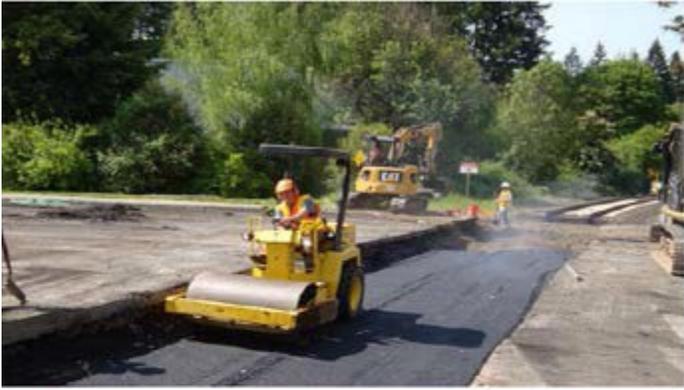
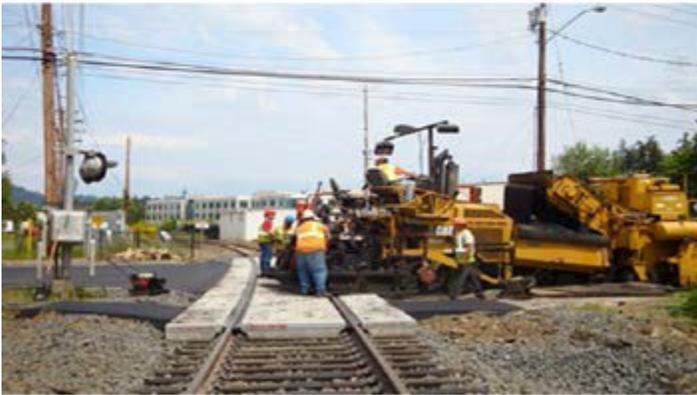
Figure 9. WES Commuter Line Crossing (SW Durham Road) on Portland & Western RR near Portland, OR, one of 13 Crossings Underlain with Asphalt.

The Genessee and Wyoming (G&W) Shortline Railroad began using asphalt underlayment on its Portland and Western (P&W) Railroad line in the state of Oregon about six years ago. P&W rehabilitates 12 to 15 crossings per year with asphalt underlayments. The TRIMET Westside Express Service (WES) commuter line, which stretches from Beaverton to Wilsonville in the Portland Metropolitan Area, utilized asphalt underlayment on 18 public crossings rehabilitated on the old Oregon Electric Line during the re-construction of the line for commuter service. These crossings have performed perfectly since the asphalt underlayment has been installed, having avoided problems with mud and requiring no additional surfacing or maintenance. Figure 9 is a view of the installation of the SW Durham Road crossing on the WES commuter line.

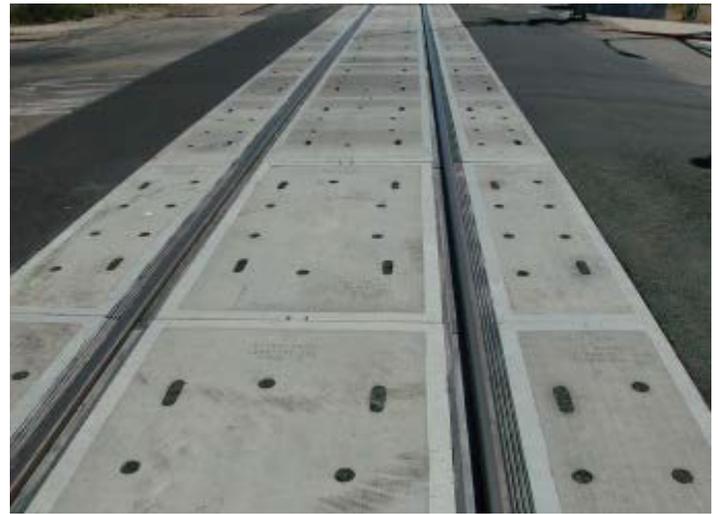
Figure 10. Recently Completed Metrolink Osborne Street Crossing on the Antelope Valley Line in the Sun Valley Area of Los Angeles.
